Success Stories

Tool Monitoring

Series #: J3674

Product: TMAC

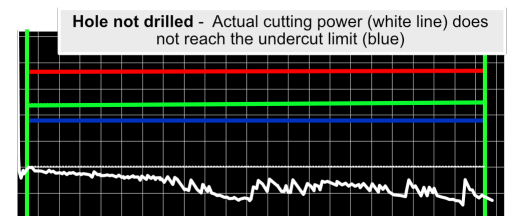
The customer implemented Caron Engineering's TMAC system. By setting an undercut limit with TMAC, they were able to detect if the hole was actually being machined. If the hole was not machined completely, an alarm would alert the operator. In addition, a TMAC extreme alarm was set to alert the operator if a tool was broken.
