TMAC Cuts Scrap Rate by Monitoring and Detecting Breakage on a .030" Drill

RESULTS – INSTALL 9930

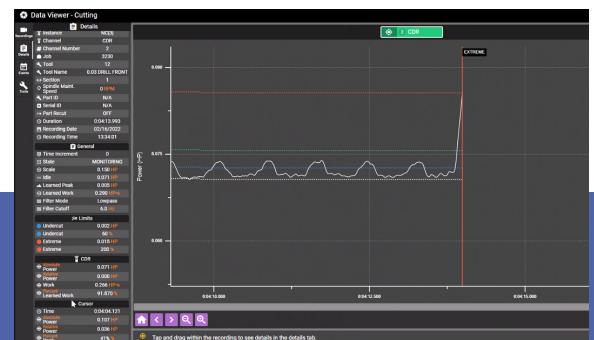
TMAC Data Viewer – shows successfully drilled holes with the last one generating an extreme alarm indicating tool breakage.

Caron Engineering installed a TMAC system with three PT800 power sensors to measure the power load used by the main spindle, power used by the 0.030" drill spindle and one for the 0.055" drill spindle. Based on learned limits, TMAC was able to determine when the tool was not cutting but should have been (i.e., broken). To do this, TMAC compares the learned cutting power to the user defined limits to detect when too much or not enough power is achieved.

When the limit is exceeded, TMAC alarms and immediately stops the process within 5 milliseconds, and retracts the tooling.
